Replace *or* Refinish?

If your worn heat transfer roller is not a 'basket case,' expert refurbishing can provide good-as-new performance while saving time and money.

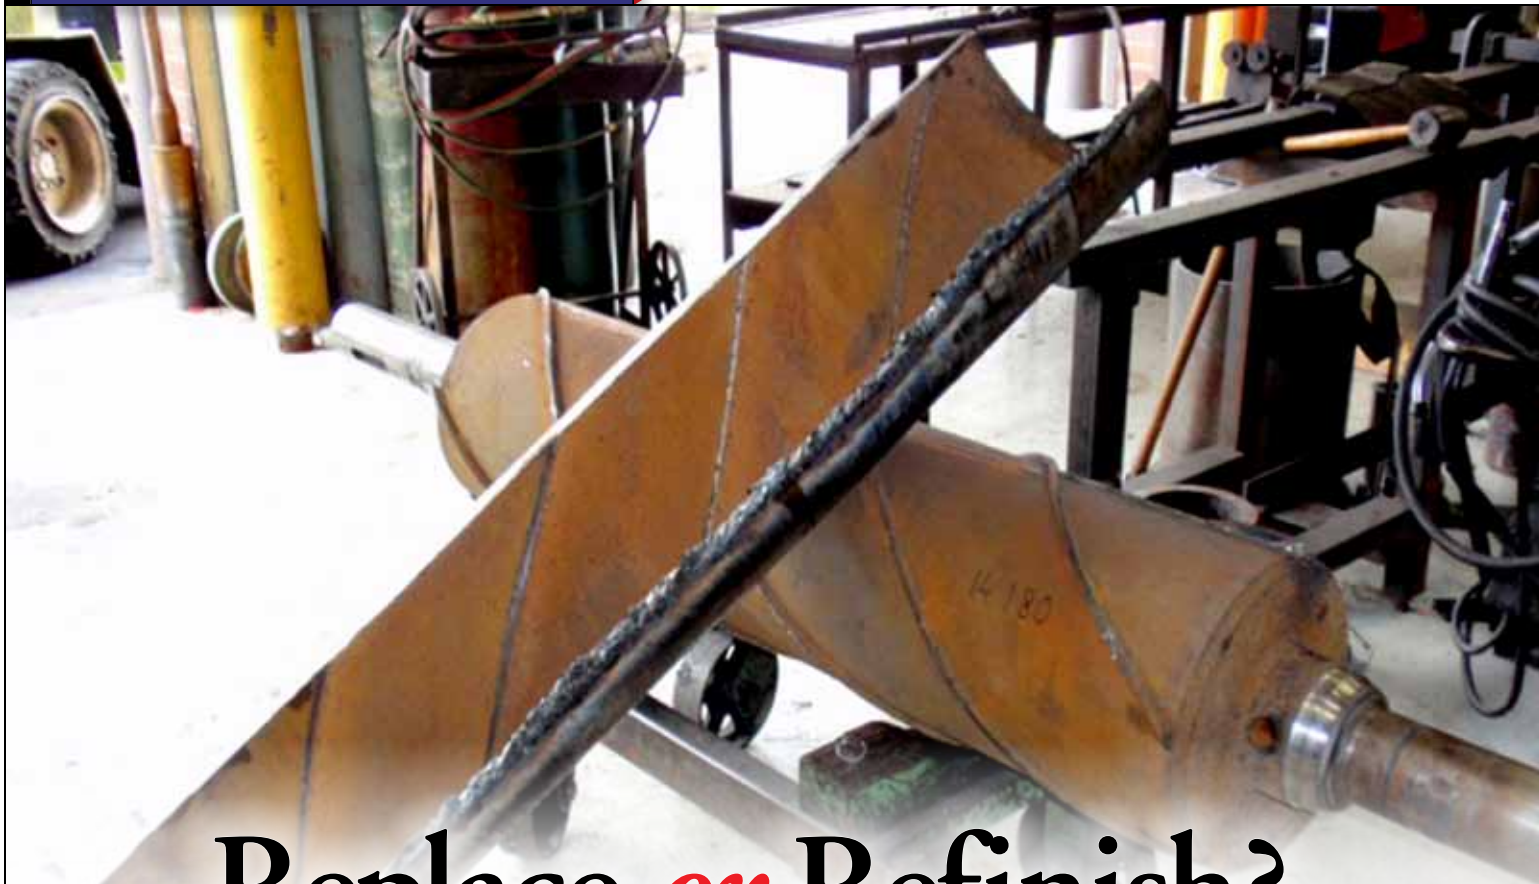
◀ **Before** | *Sonoco Clear Pack needed to repair one of its large heat transfer rolls at the firm's sheet extrusion operation. When the outer shell was removed, a number of internal problems, including some leaks, were identified and repaired.*

Brian Varley, plant engineer at Sonoco Clear Pack, Franklin Park, IL, needed to repair or replace one of the large heat transfer rolls at the firm's sheet extrusion operation. "The shell surface on one of our tungsten carbide rolls was excessively porous," Varley explains, "so it would not accept replacement tungsten carbide well enough and would not polish properly."

Even with laser welding, the roll supplier determined that the super-finish required for application could not be achieved. "They removed the outer shell, installed a new one, and applied the tungsten carbide super finish to the roll," Varley says. "However, once they removed the shell, they found a number of other problems in the roll's internals. There were some leaks that they were able to repair, and they also rebalanced the roll. After the refurbishing, which was done fairly quickly by Menges Roller, we had a virtually brand-new roll for less than half the price of fabricating a complete replacement."

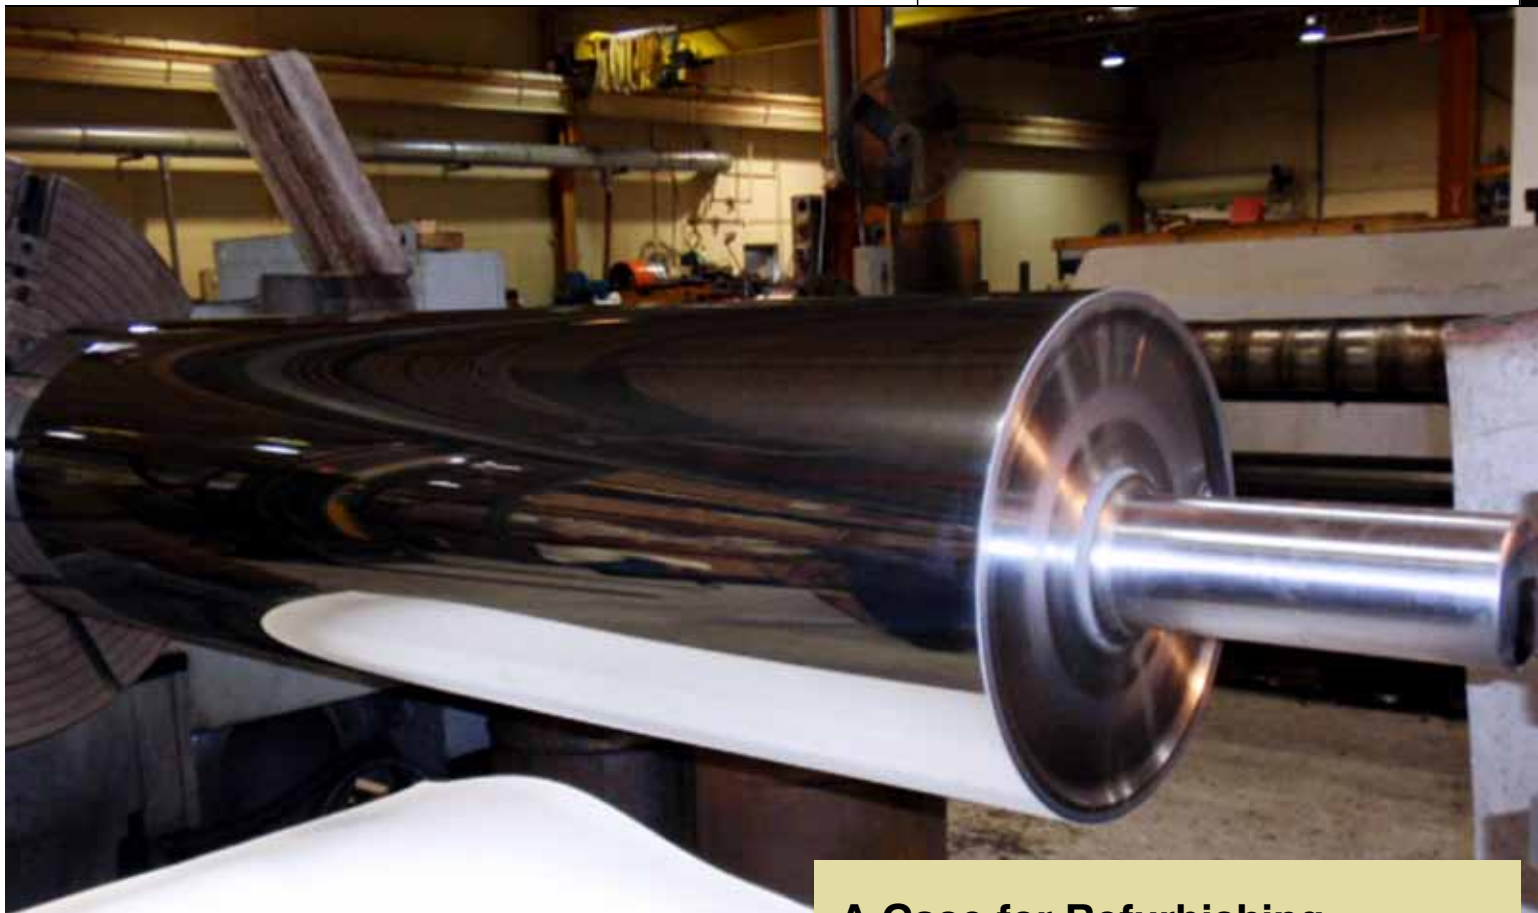
▲ **After** | *A new outer shell was installed, and a tungsten carbide super finish was applied to the roll. The refurbishing, which was done fairly quickly, cost less than half the price of fabricating a complete replacement.*
