# CONVERTING QUARTERLY

# Seamless roll coverings for coating, cast-film production

By Matthew Menges, president, Menges Roller Co., Inc.

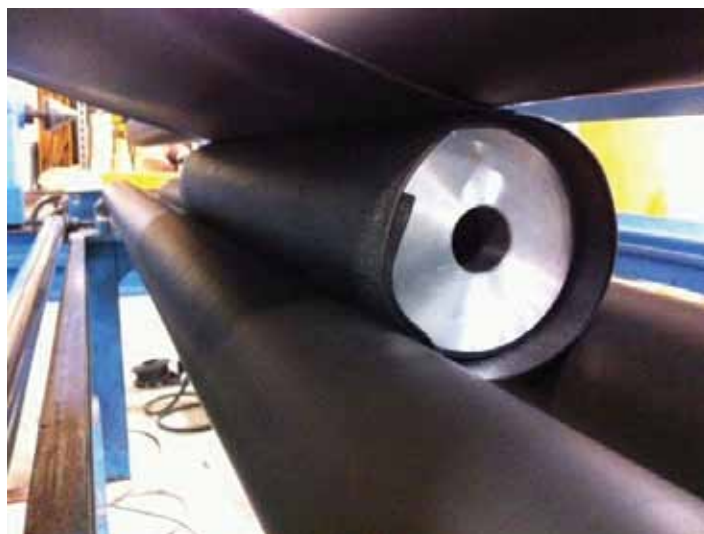
FIGURE 1. “Calender”-built rubber-roll covering

Rubber is applied to a roll core in either of two methods: “Calender” built or “strip” built. Calender building is winding the rubber on to the core much like a window shade (see Figure 1). The rubber is attached to the core and then the core is rotated, usually in a carriage of rollers that apply pressure to the rubber as it is being wound to remove air between the layers. This method is good, except that rubber calenders are limited in width to approximately 65 in. If the roller is wider than 65 in., another piece of rubber needs to be butted up to the end at 65 in., and it

leaves a seam around the roller. In addition, the rubber — as it is applied to the roll core — leaves a longitudinal line across the face once the roller is finished. This line appears as a stripe across the face. As the calender rubber is applied and the supply roll of virgin rubber comes to an end, another piece has to be applied, which creates the possibility of another stripe across the roller when it is finished.

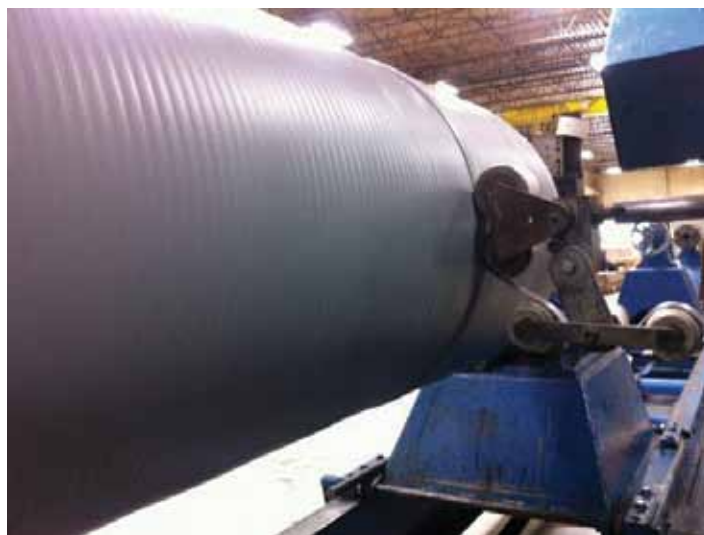
FIGURE 2. “Strip”-built rubber-roll covering

The second rubber-application process is the extrusion method, known as “strip” built and mostly commonly used for large rollers (see Figure 2). Rubber is mixed and then stripped off a rubber mill in 3-4 in. strips approximately 3/8-in. thick. The roll producer typically inventories these for ready production. The strip is fed into a rubber extruder where the screw remixes the rubber and feeds it through a series of extruder screens that filter and remove any undispersed ingredients or foreign material. The rubber then exits the extruder through a die that profiles the strip for the best lay up for building the roller.

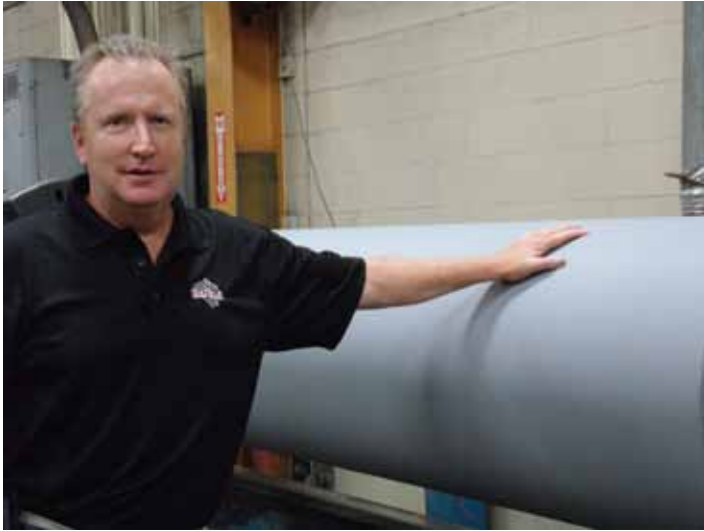
**FIGURE 3.** “Lapping” process, seamless rubber-roll covering

The roller manufacturer has to recognize the properties of this raw non-vulcanized rubber to allow for best knitting and crosslinking during the extrusion and vulcanization process. This firm has developed a proprietary process to ensure that the rubber, once applied, will become a monolithic sleeve of rubber with all of the exact same properties throughout the entire covering (see Figure 3). This process, called “lapping,” uses the best strip profile, rubber chemistry and vulcanization techniques and flow-rate calculations to allow the rubber to stay rested during the application process and to eliminate rubber memory. “Rubber memory” is the term given to rubber because the material “remembers” everything that has happened to it prior
